APPLICATION OF INCLINOMETER MEASUREMENTS FOR RELATIVE HORIZONTAL DISPLACEMENT INVESTIGATIONS ON LANDSLIDE GROUNDS

Ryszar Malarski, Kamil Nagórski, Marek Woźniak

Warsaw University of Technology
Faculty of Geodesy and Cartography
Department of Engineering Surveying
Warsaw, Poland

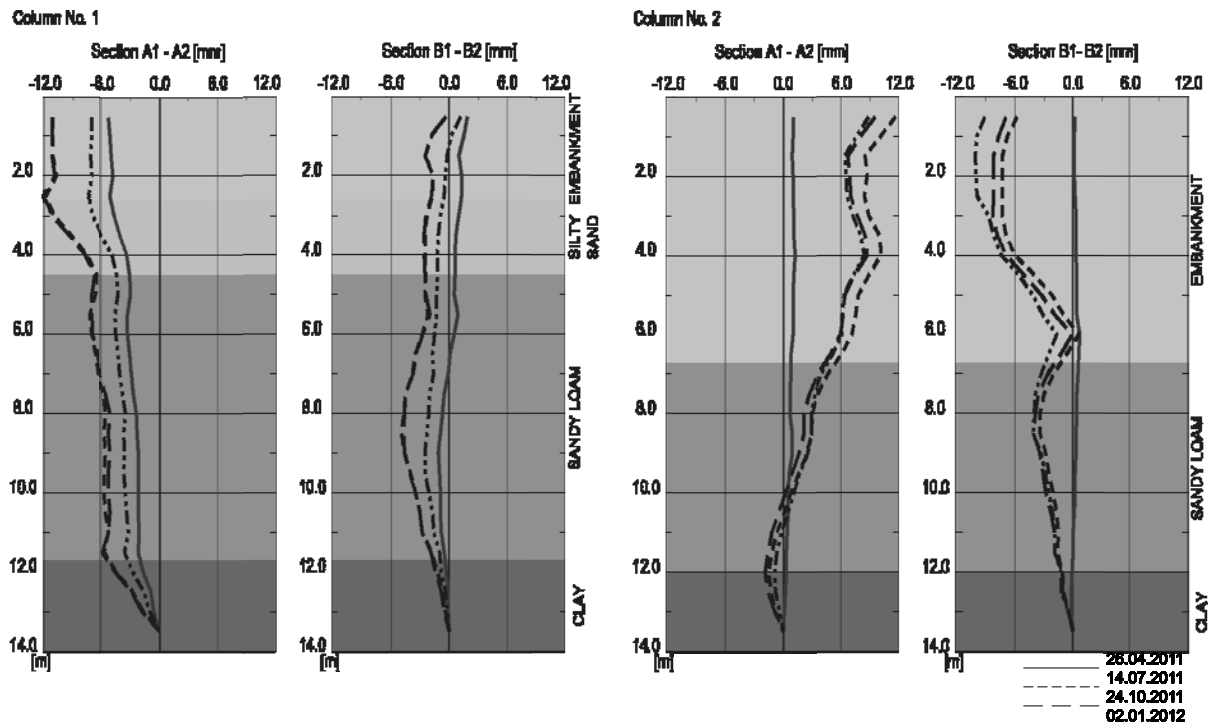
Fig. 4. The graphs of horizontal displacement in relation to hill side foot

Observations of inclinometer No.1 indicate relative horizontal ground displacements. It is well seen from diagram in Fig. 4 a displacement trend due to heavy rainfall spell, which subsides during the period from July to October.

Data collected with inclinometer No.2 indicate existence of relative ground displacement. Displacement trends towards retaining wall are distinct. In the period from October 2011 up to January 2012 reverse trend is evident. In the upper part of column sheltered by 5.5 m thick retaining and unsheltered (exposed) part at 3m height could be explained by thermal expansion. One has to notice that ground consists mainly of sand and brick rubble in this area. Noticeably, there is change of displacement trend from the base of column at the depth of 11.5 m cross section A1-A2 and for cross section B1-B2 at the depth of 9m. It is supposed that the column gets through a layer of Tertiary Period silty clay. Relative horizontal displacements referring to level depth of 11.5 m are presented in Fig 5.

Data collected with inclinometer No.2 indicate existence of relative ground displacement. Displacement trends towards retaining wall are distinct.

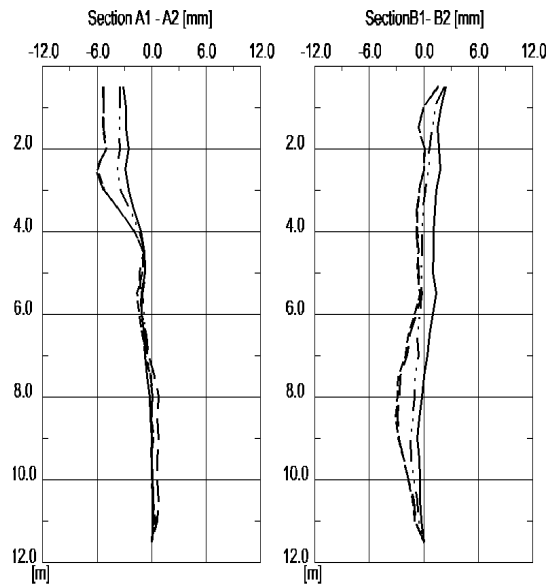
This example shows how crucial is in ground deformation measurements and slope ground deformation measurements, adequate positioning of inclinometer column base.

In case of positioning column No.1 at the same reference level instead of column No.2 any significant change in displacement of ground at the adjacent layers of clay and sandy loam could have been found.

Fig 5. The graph of relative horizontal displacements referring to level depth of 11.5 m in column No.1

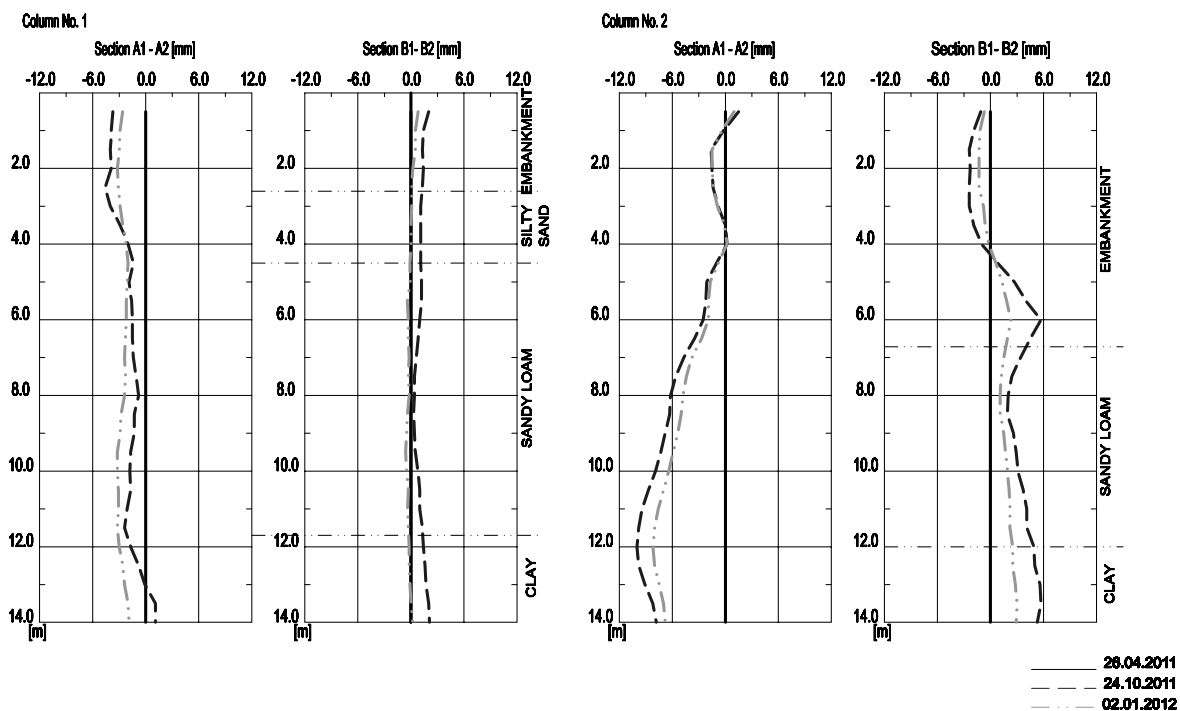
Absolute horizontal displacements in columns No.1 and No.2 are presented on diagrams in Fig 6.

Taking comparison between relative displacements [Fig 4] and absolute displacements [Fig 6] one can easily notice that detected changes take place in a clay layer spread over several meters under ground surface.

Fig. 6. The graphs of absolute horizontal displacements in column No.1 and No.2

Inclinometer observations should be extended and supplemented by absolute horizontal displacement measurements of inclinometer head to asses thoroughly ground position changes.
