Investigating diverse photogrammetric techniques in the hazard assessment of historical sites of the Museum of the Coal Basin Area in Będzin, Poland

Abstract

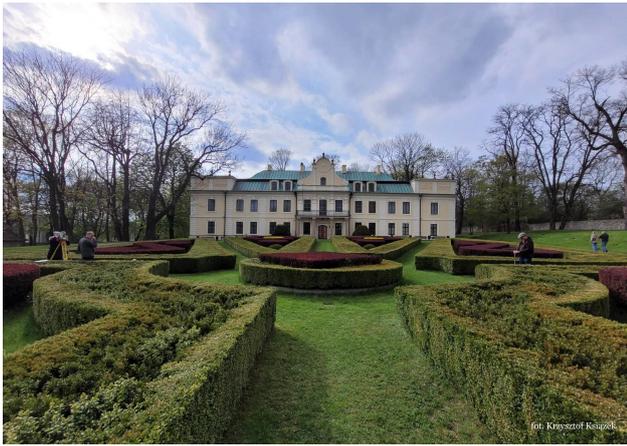
Figure 1. The Mieroszewski Palace in Będzin – 1702

The Mieroszewski Palace was built in 1702 and was a typical 18th-century noble French-style residence (Figure 1). It is a one-story palace with a double-arched mansard roof and an amphitheatre-like arrangement of rooms. Rich polychrome paintings dated to the 18th century are on the interior walls. On the eastern side, a wide driveway leads to the main entrance. In addition, on the west side, there is a park with stone sculptures and interesting tree specimens. The whole forms an architectural layout, reflecting an 18th-century park and palace composition (Museum of the Coal Basin, 2024).

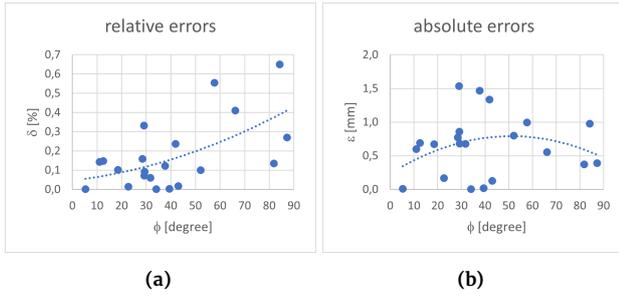
Figure 13. The dependence of section length errors between façade control points and the direction of the section in the façade plane, presented in the form of error: (a) – relative calculated from Equation (3); and (b) – absolute calculated from Equation (2) (trend lines generated using polynomials of the second order)

Interpreting the effect of the direction of the section between two points, it should be noted that the relative errors of the sections between the façade control points are smaller for $\varphi = 0^\circ$ (vertical sections) than for $\varphi = 90^\circ$ (horizontal sections). As the direction increases, these errors increase. In contrast, the relative errors of the sections between tie points are smaller for $\varphi = 90^\circ$ (vertical sections) than for $\varphi = 0^\circ$ (horizontal sections). This fact is consistent with the geometry of the distribution of the different types of

In turn, the absolute errors of the sections between the façade control points are the largest for oblique directions. This is evidenced by the convexity of the trend function. In contrast, the absolute errors of sections between the tie points show a decreasing trend as the direction φ increases. These results suggest greater accuracy of linear quantities measured along the length of the wall than those measured along the height of the wall. This direction is consistent with the measurement of the width of vertical cracks on the façade.

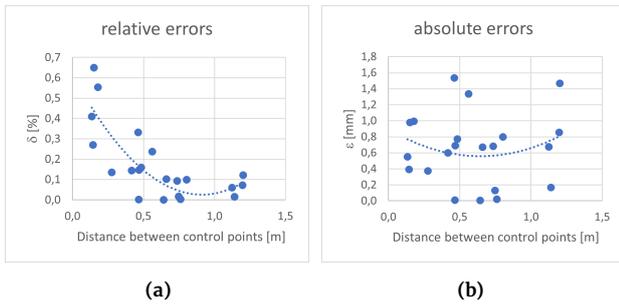
Figure 14. The dependence of section length errors between façade control points and section length in the façade plane presented in the form of error: (a) – relative calculated from Equation (3); and (b) – absolute calculated from Equation (2) (trend lines generated using polynomials of the second order)

The correlation between the accuracy of the lengths of all possible combinations of segments, the lengths of these segments, and the direction of these segments are shown using graphs. Figure 13 shows the dependence of the relative (Fig. 13a) and absolute (Fig. 13b) errors of the lengths of the sections between the façade control points and the direction of the section in the façade plane. Figure 14 shows the dependence of the relative (Fig. 14a) and absolute (Fig. 14b) errors of the lengths of the sections between the

Interpreting the effect of the segment length between two points, it should be noted that as this length increases, the relative errors of the distance between the façade control points and tie points decrease. A decreasing trend can also be observed for the absolute errors of the distance between the tie points. On the other hand, in the case of absolute errors of distance between the façade control points, there is a large dispersion of points.

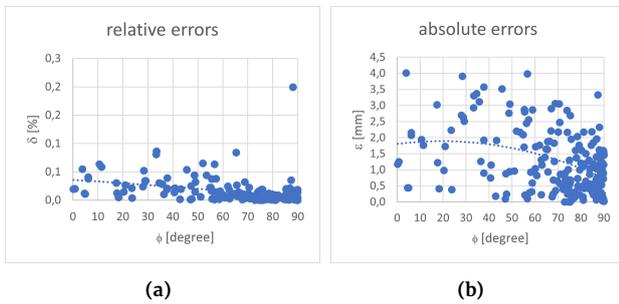
Figure 15. The dependence of segment length errors between tie points and the direction of the segment in the façade plane presented in the form of error: (a) – relative calculated from Equation (3); and (b) – absolute calculated from Equation (2) (trend lines generated using polynomials of the second order)

façade control points and the lengths of these sections in the façade plane. Similar graphs were generated for tie points. Figure 15 shows the dependence of the relative (Fig. 15a) and absolute (Fig. 15b) errors of the lengths of the sections between tie points and the direction of the section in the façade plane. Figure 16 shows the dependence of the relative (Fig. 16a) and absolute (Fig. 16b) errors of the lengths of the sections between tie points and the lengths of these sections in the façade plane. The point plots also include trend lines in the form of second-order polynomial functions that approximate the scatter.

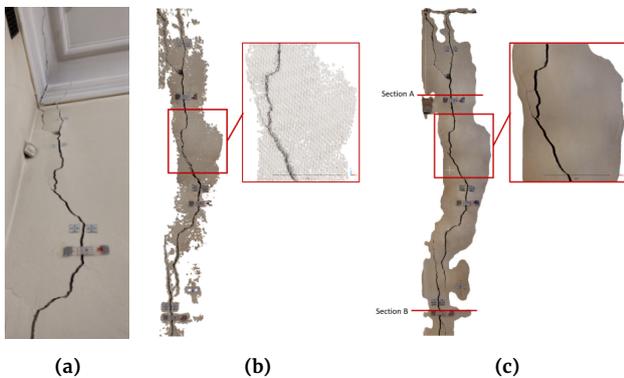
**Figure 17.** The results of the inventory of the cracks on the inner walls of the Mioszowski Palace: (a) – a photograph of the crack; (b) – a point cloud representing the crack, generated using the Pix4Dcloud application based on images acquired with the Pix4Dcatch application installed on a smartphone; (c) – a TIN model of the crack, generated using mobile technology with a smartphone

Figure 17 shows all the resultant products, such as cracks. Figure 17b shows the point cloud that represents the crack. It was generated using the Pix4Dcloud app based on images acquired using the Pix4Dcatch app installed on a smartphone. The cloud in Figure 17b has a 100 points/cm² density. This shows that the distance between cloud points is about 1 mm. In turn, Figure 17c presents the TIN model which is a triangle mesh formed from the point cloud and the texture of the images. Measuring with a precision of more than 0.5 mm on the TIN grid is possible. Such a high density of the point cloud and the resolution of the TIN model is due to the short distance between the registered object and the camera.
