APPLICATION OF INCLINOMETER MEASUREMENTS FOR RELATIVE HORIZONTAL DISPLACEMENT INVESTIGATIONS ON LANDSLIDE GROUNDS

Ryszar Malarski, Kamil Nagórski, Marek Woźniak

Warsaw University of Technology
Faculty of Geodesy and Cartography
Department of Engineering Surveying
Warsaw, Poland

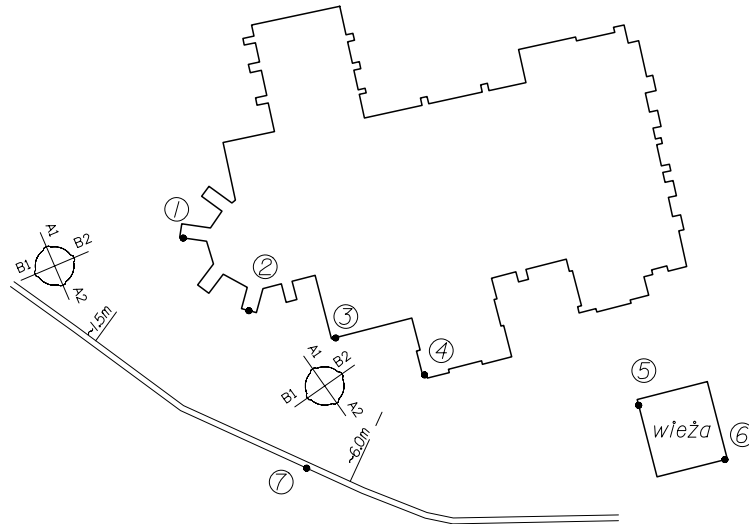
Fig. 3. The sketch of the location of inclinometer columns

Inclinometric measurements were applied to detect changes in the slope at different levels. In order to achieve that two 14m deep inclinometric columns were embedded beneath ground level (Fig. 3.).
